Technical Note N-607

EARTHQUAKE DAMAGE TO ANCHORAGE

AREA UTILITIES - MARCH 1964

J. M. Stephenson

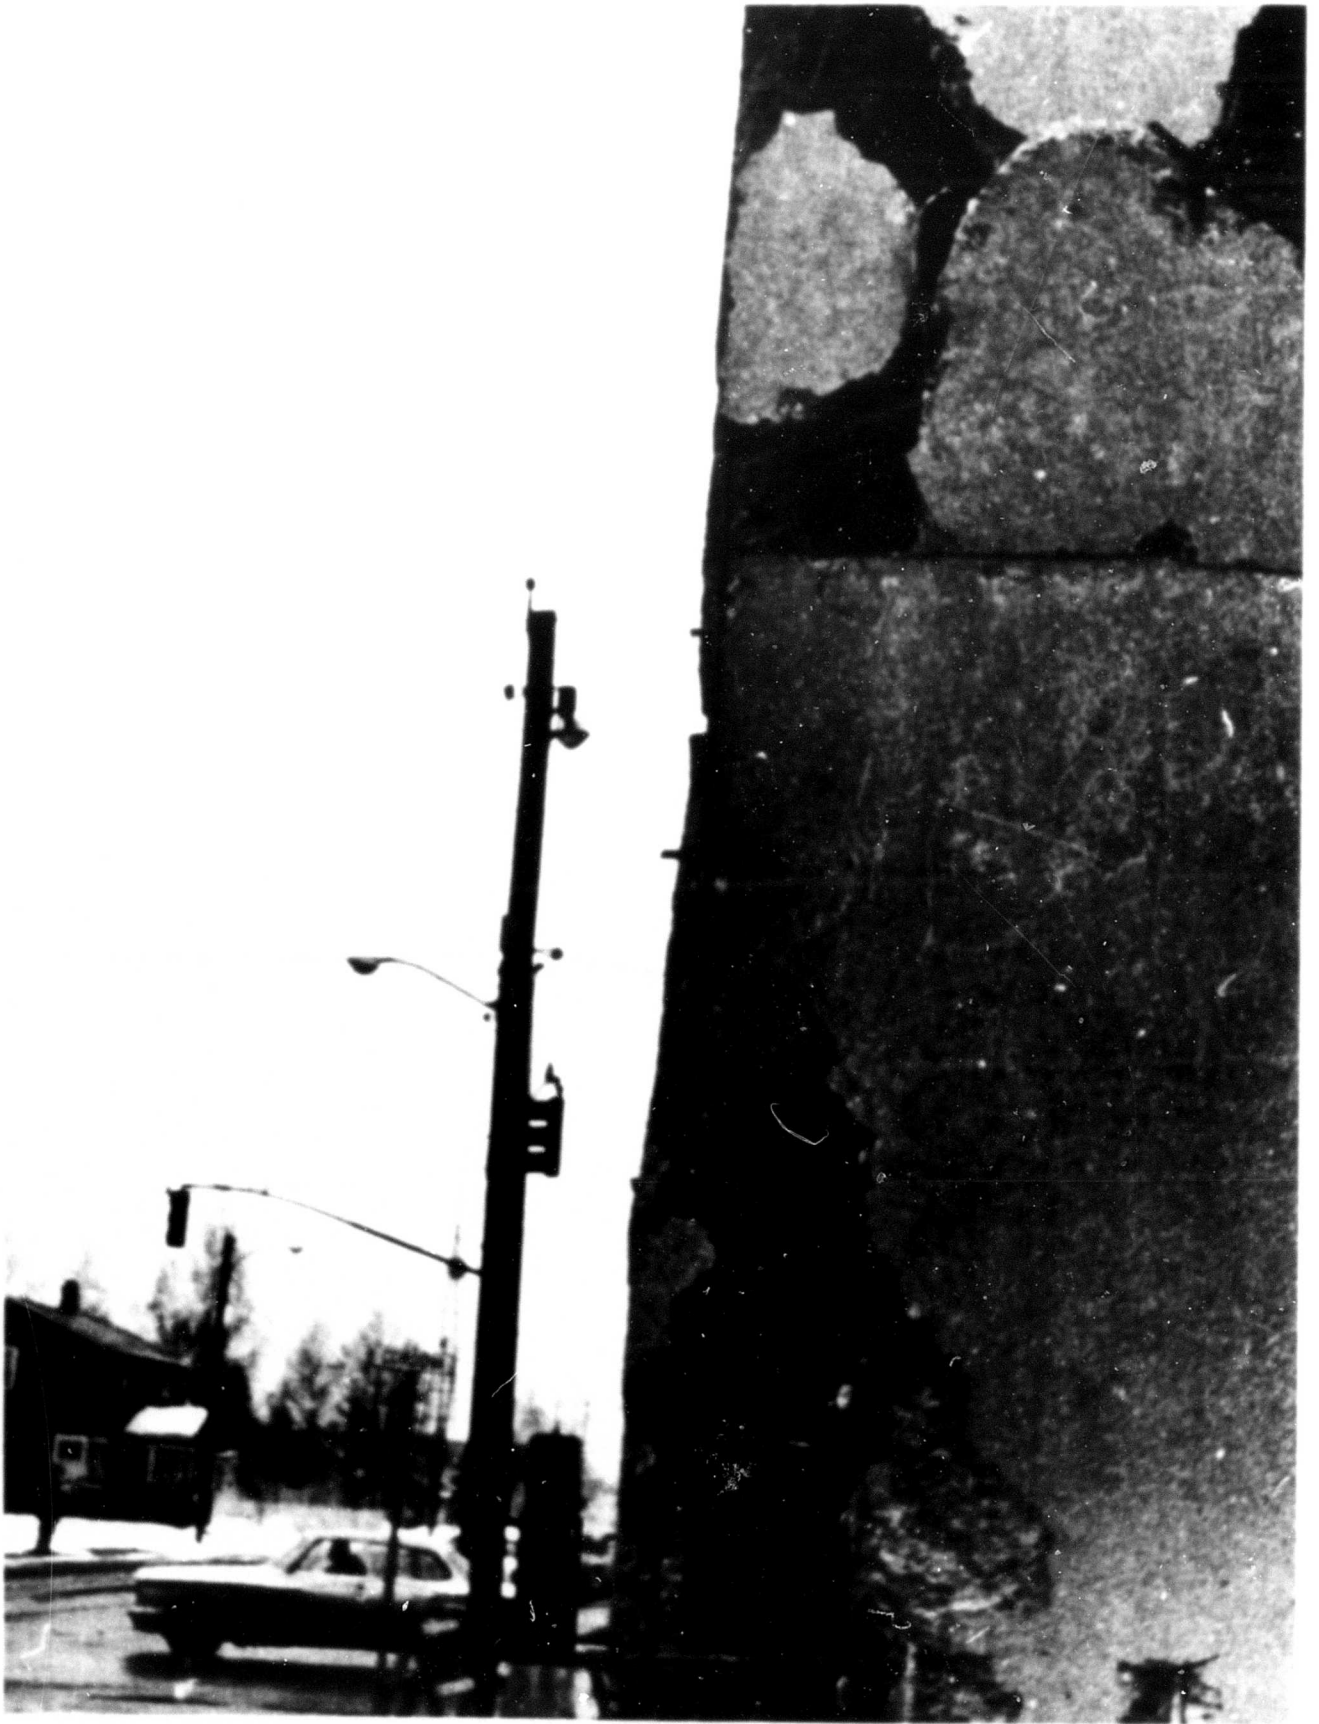
Figure 4. Utility pole beside Cordova Building.

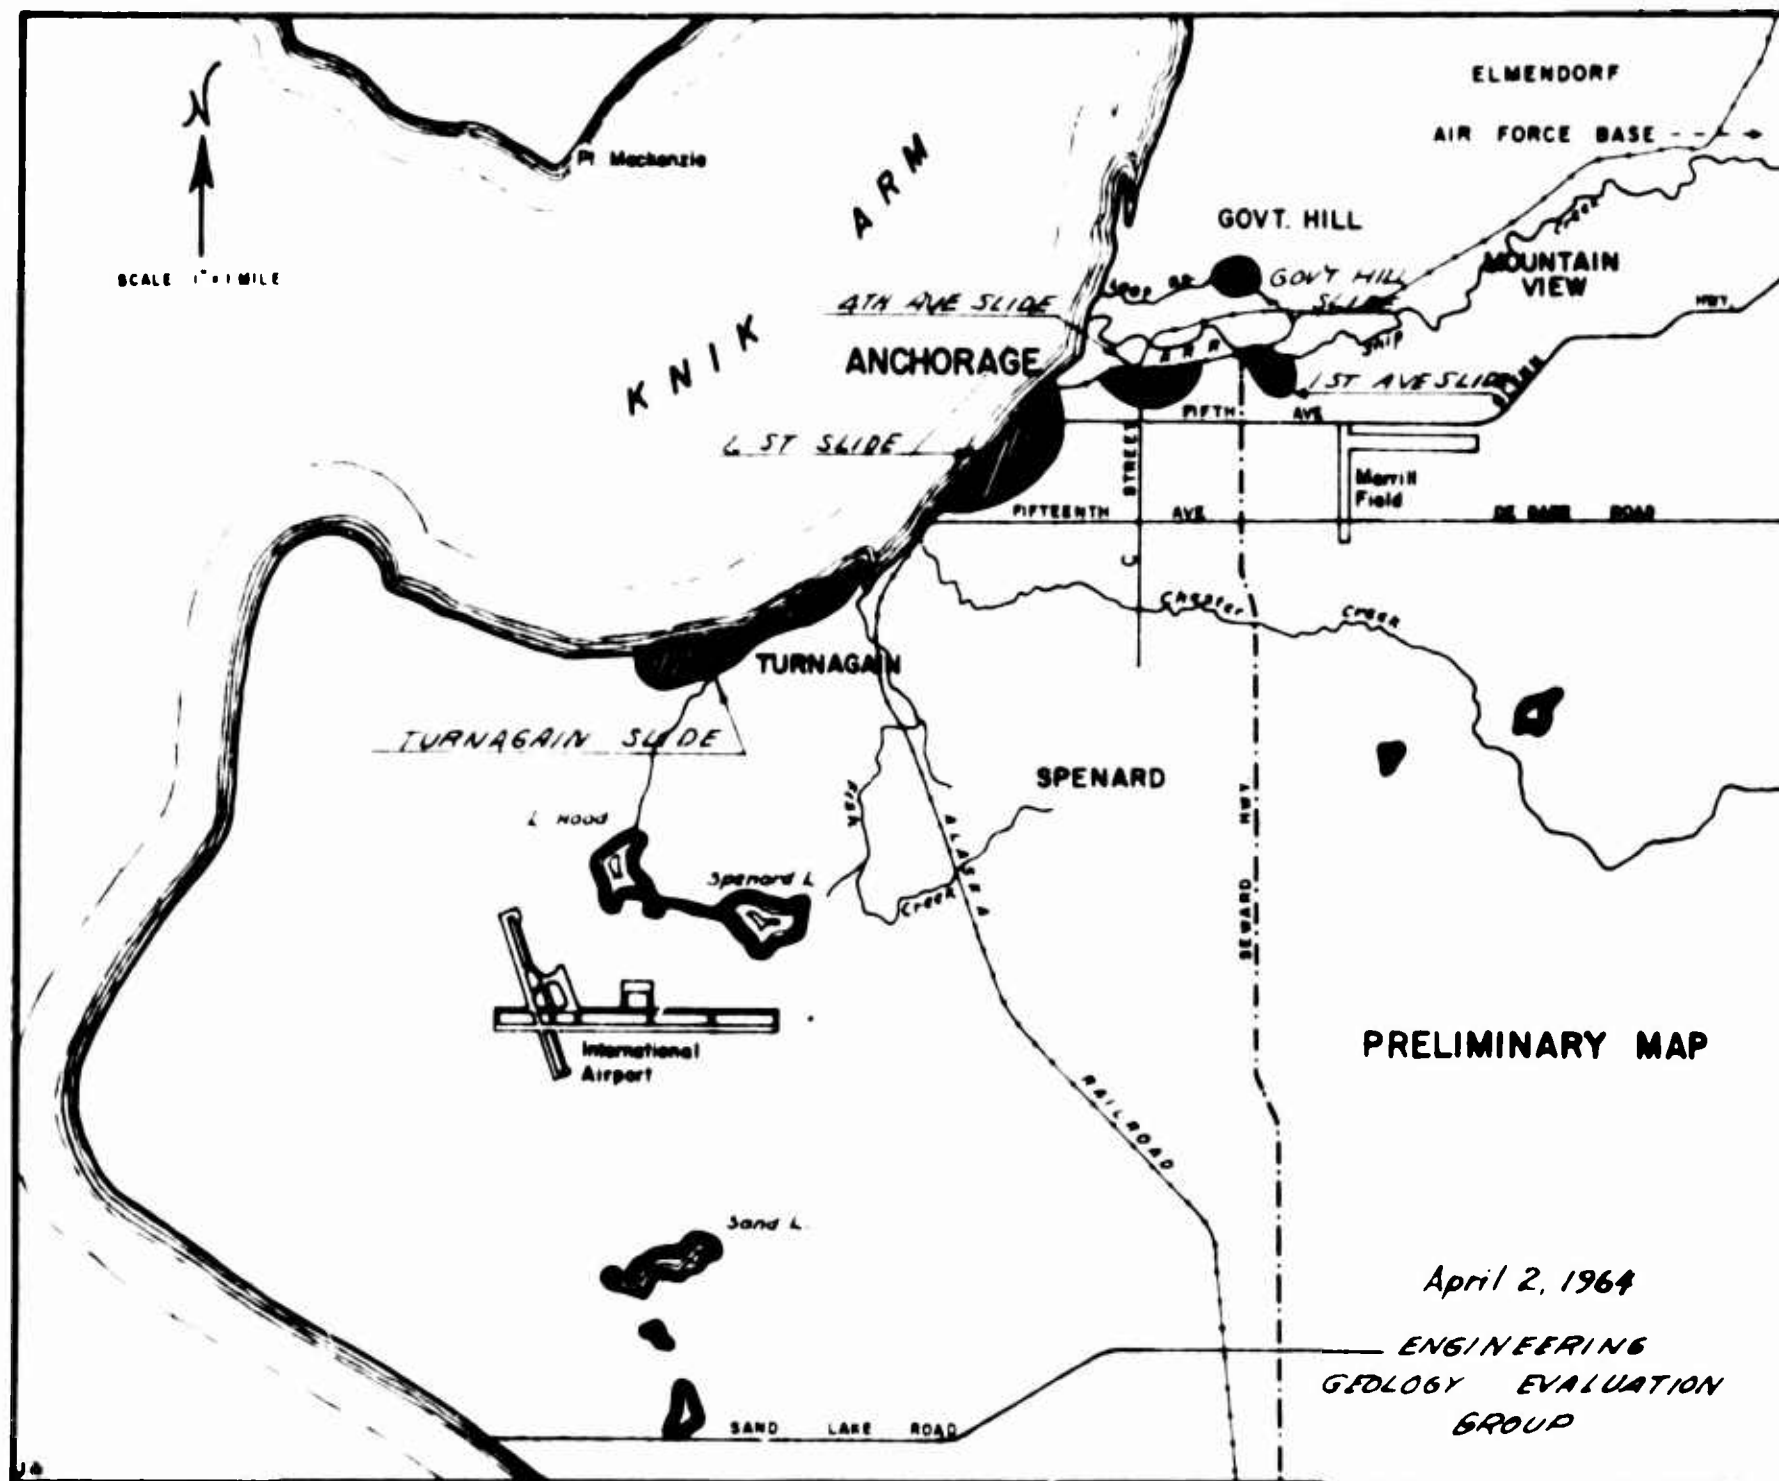
When the earthquake struck, a number of things happened simultaneously which in a few hours left the whole area with only a meager supply of water. Landslides (Figure 12), tension breaks in the ground (Figures 13 and 14), and building movements (Figures 15, 16, 17 and 18) broke water mains in many places putting a heavy drain on the reservoir. In the meantime, a slide upstream from the dam stopped the flow of

Figure 12. Anchorage slide areas.

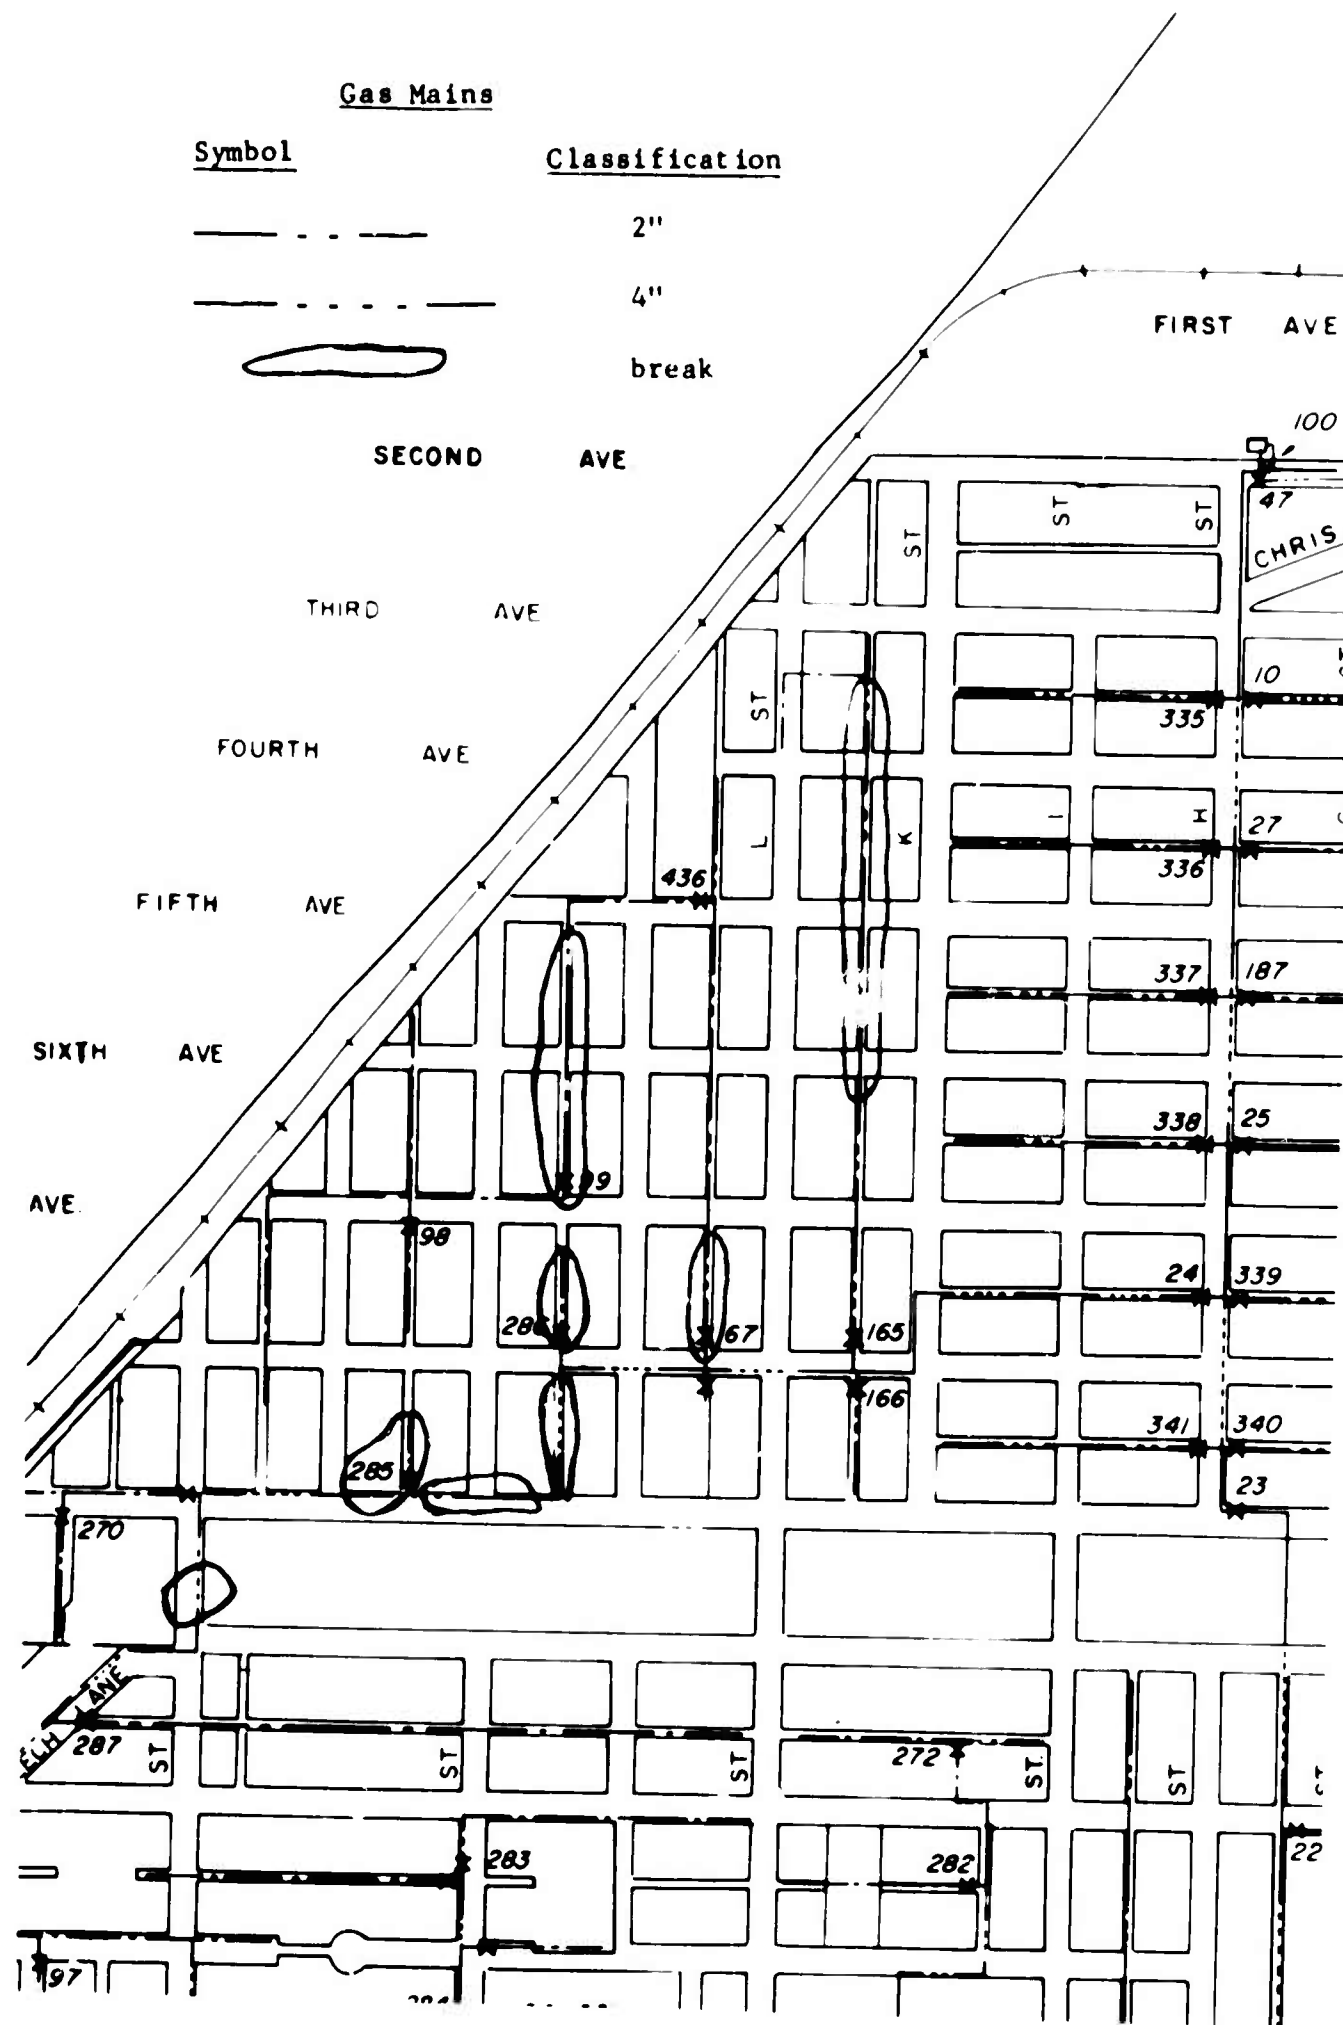
Figure 20. Gas line breaks in "L" street slide area.

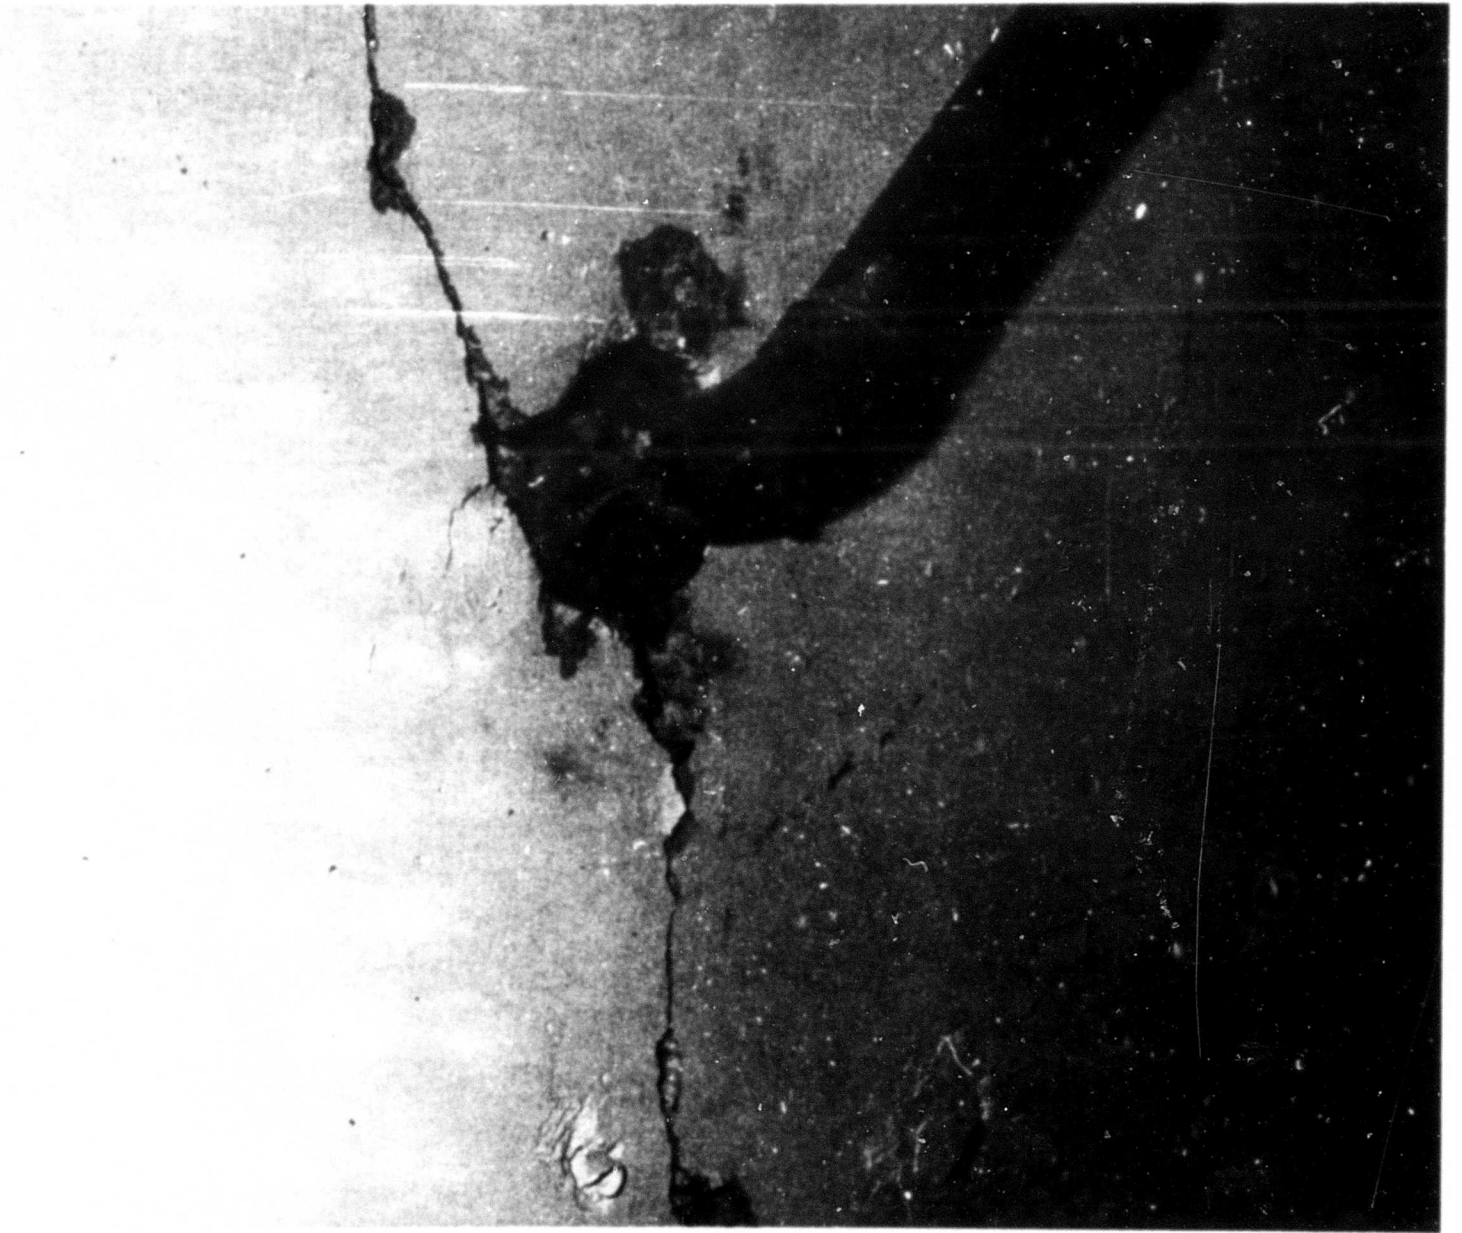
In spite of the serious structural damage the mechanical equipment survived remarkably well. The boilers, fans, coils, ductwork, and telephone equipment, including batteries, were virtually undamaged. In more typical fashion a number of hangers were broken and pipes were sheared where the pipes and buildings could not move together or independent of each other (Figure 23).

Figure 23. Pipe rupture in Hill Building (Small displacement)

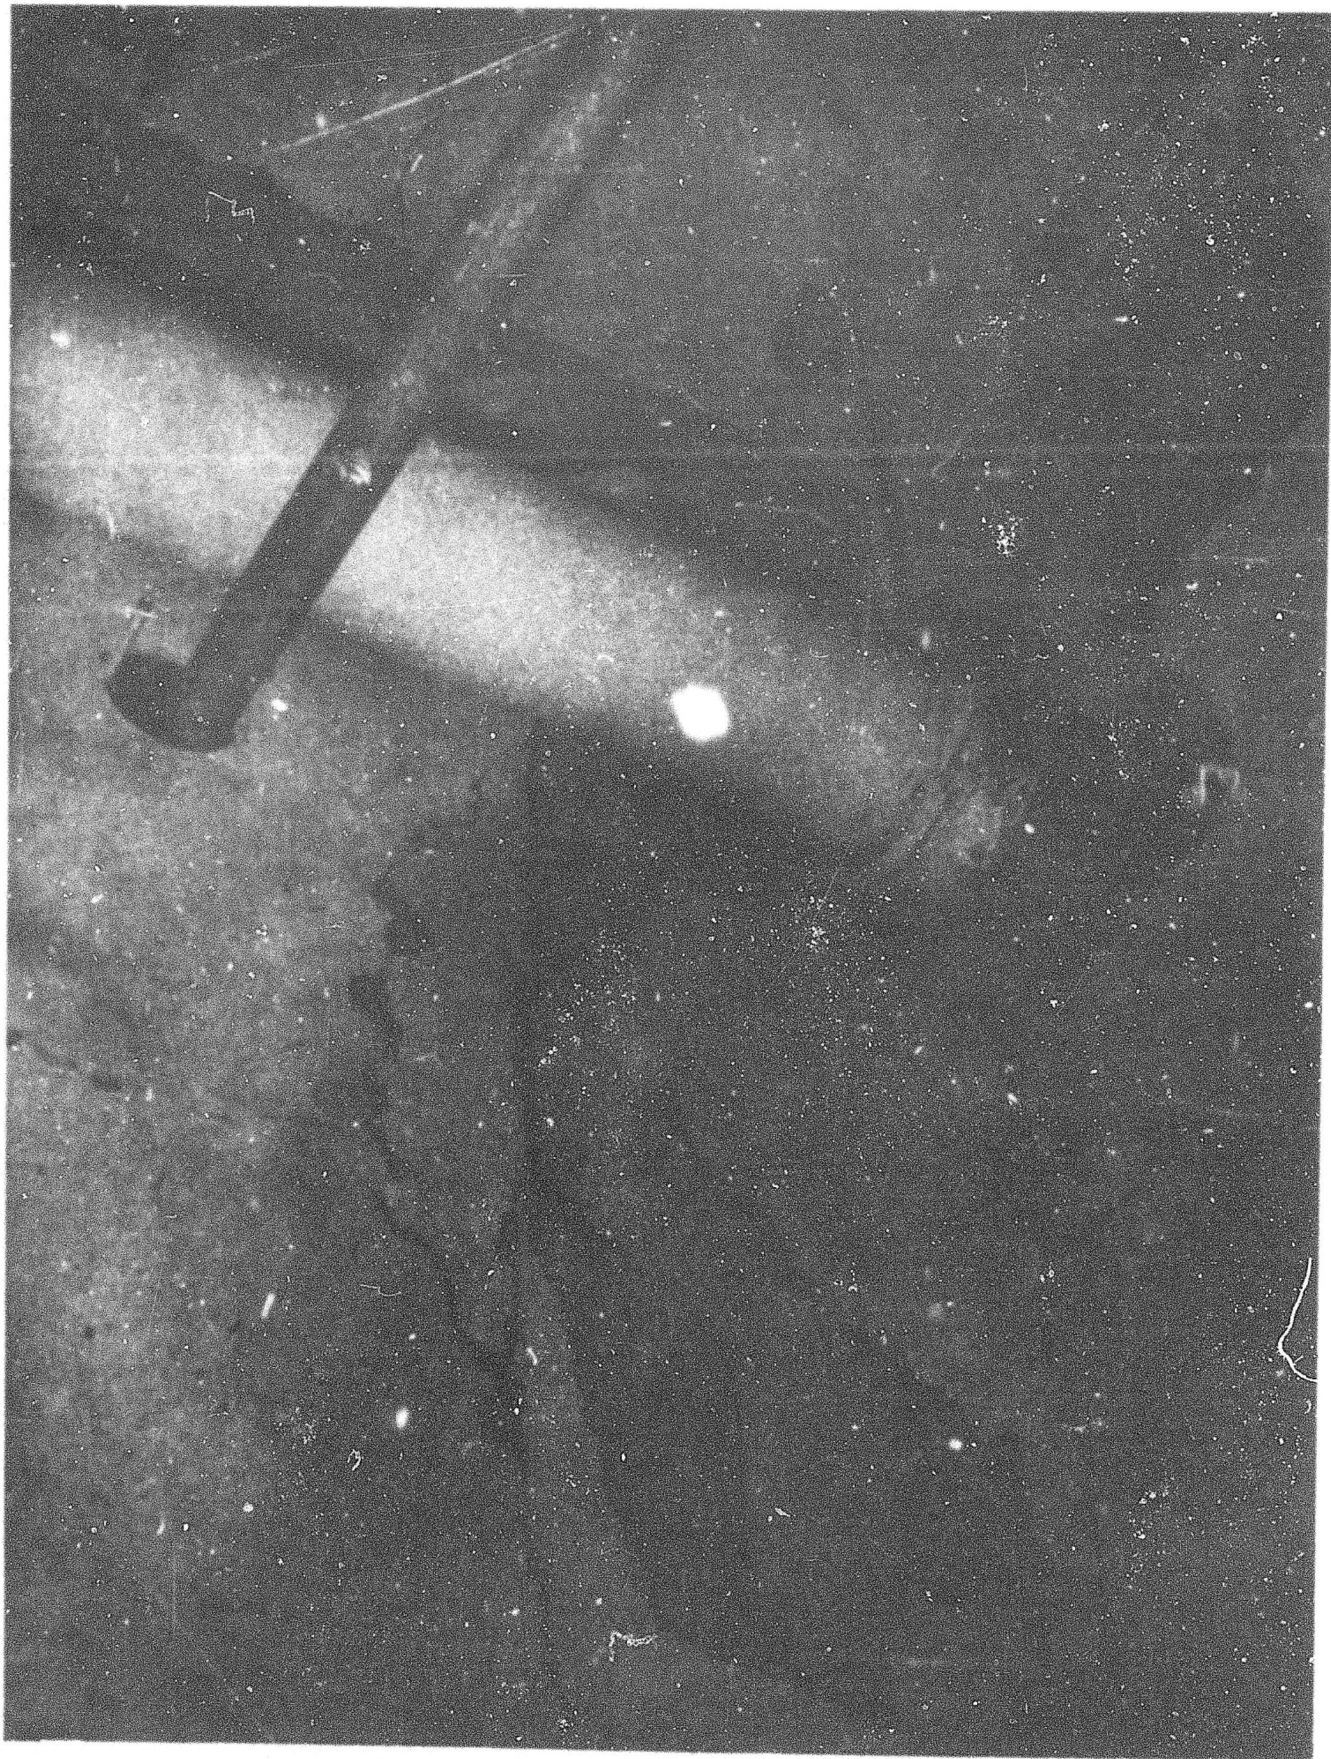
The pipes shown in Figure 24 are located in the same room as the one in Figure 23, but no breaks occurred in these pipes because they had adequate freedom of movement. As shown previously in Figure 10 a piping system designed with swing joints which allow it to move relative to the building can sustain a lot of motion without damage. Probably the most serious damage was sustained by the elevators where the counterweights pounded against their guides as they did at the Elmendorf Air Force Base Hospital.

Figure 24. Undamaged pipes in Hill Building (large displacement).

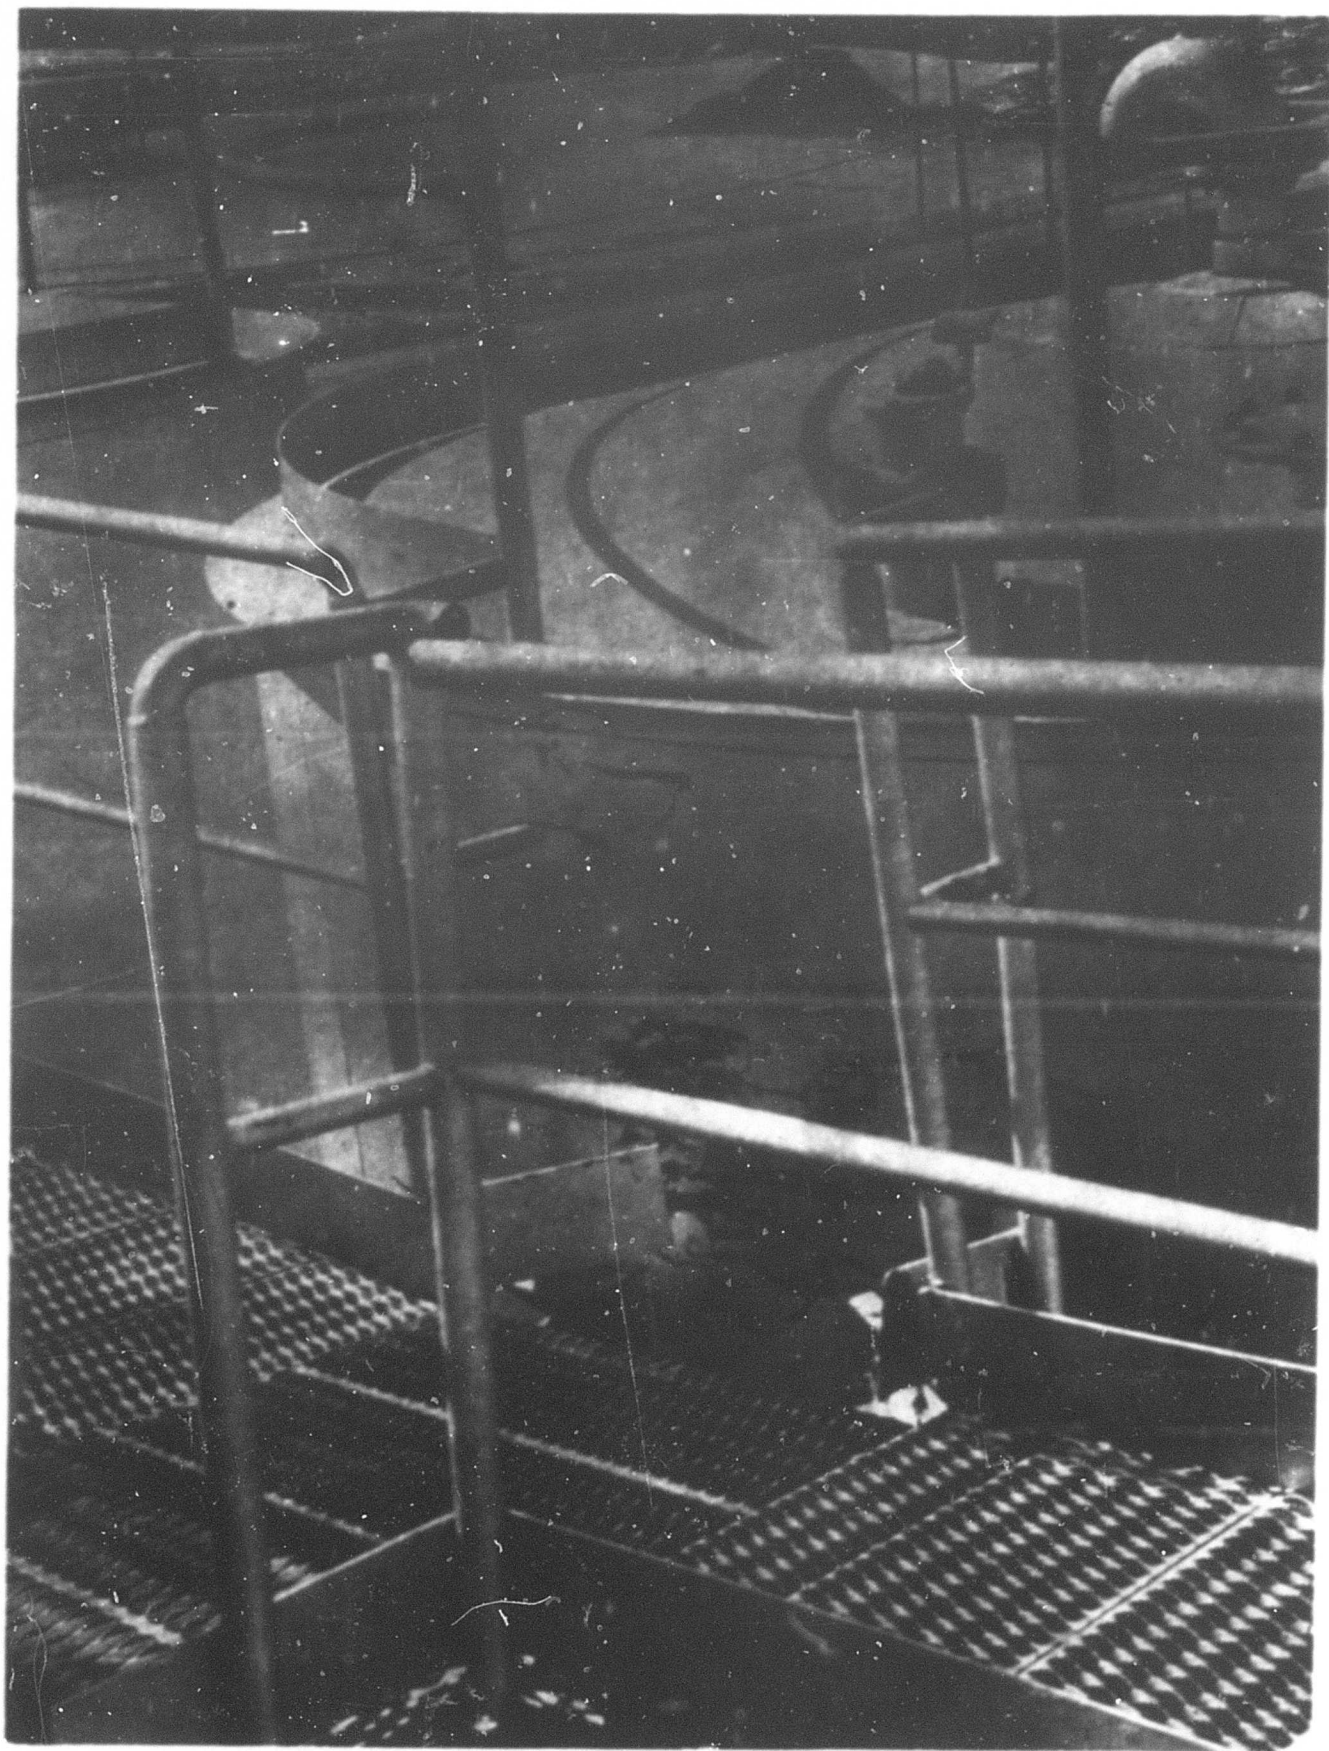
Figure 32. Scratches indicate hammering between tank and catwalk.

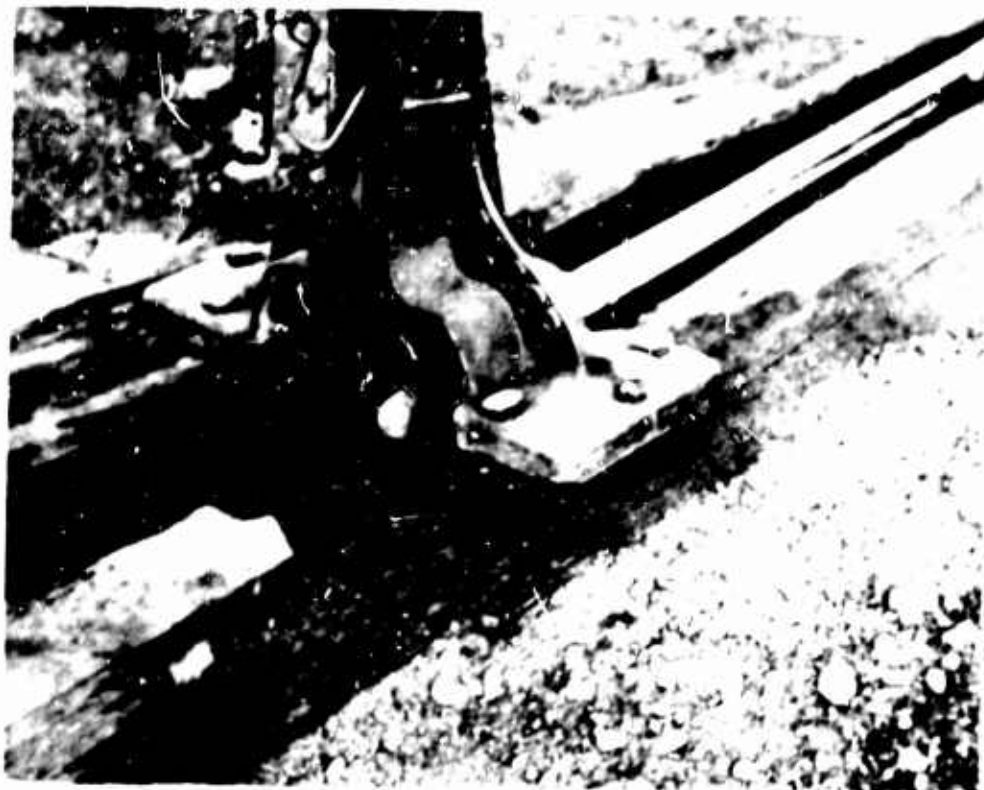
Although damage to railroads throughout Alaska mounted to several millions of dollars, the damage in Anchorage was not extensive. Tracks were disrupted in some areas or put out of line in a snakelike fashion as witnessed near the Anchorage dock, Figures 33 and 34. Many spikes along the tracks and around switching gear were displaced one or two inches, Figure 35.

Figure 35. Railroad spike displacement.

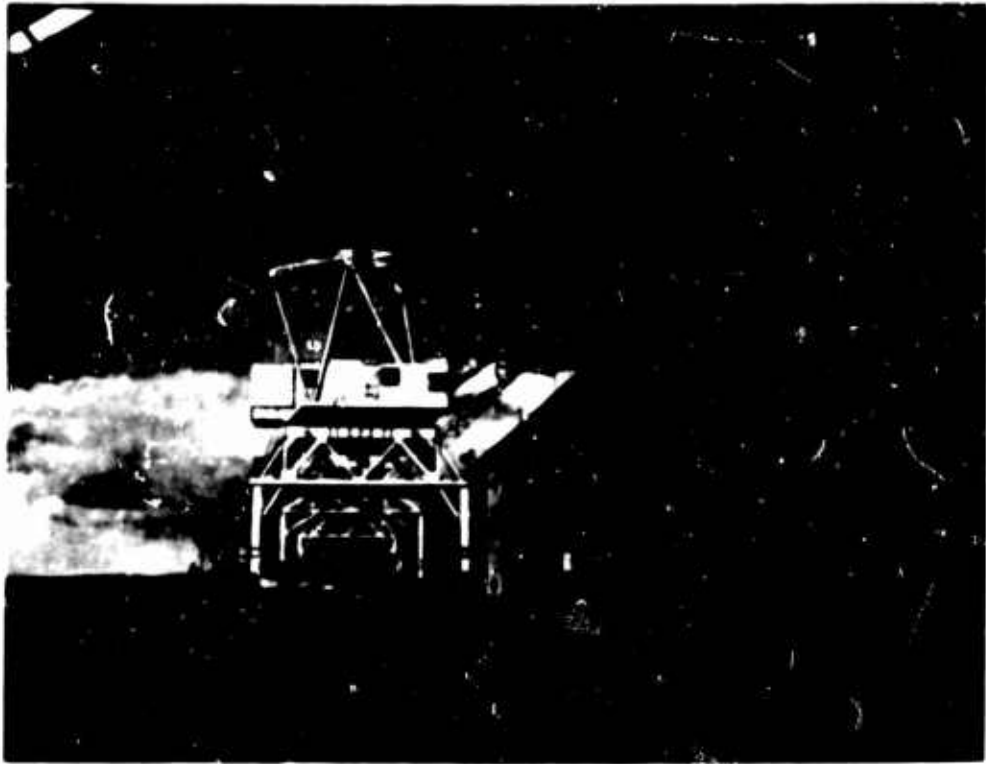
At the Port of Anchorage were five gantry cranes (Figure 37) whose counterweights were set in motion by the earthquake. As a result of this motion the counterweight arms were twisted and broken and two of the 50-ton weights fell into the water and sank in the mud. The city port dock, built with steel piles, suffered very little damage (Figure 38), however the army dock nearby built with wooden piles was put out of service (Figure 39).

Figure 37 Dock cranes at the Port of Anchorage with counterweights in place.
